PRELIMINARY REPORT ON SEISMIC TESTING OF A FULL-SCALE SIX-STORY STEEL BUILDING

By
DOUGLAS A. FOUTCH
SUBHASH C. GOEL
CHARLES W. ROEDER

UNIVERSITY OF ILLINOIS
AT URBANA-CHAMPAIGN
URBANA, ILLINOIS
NOVEMBER 1986

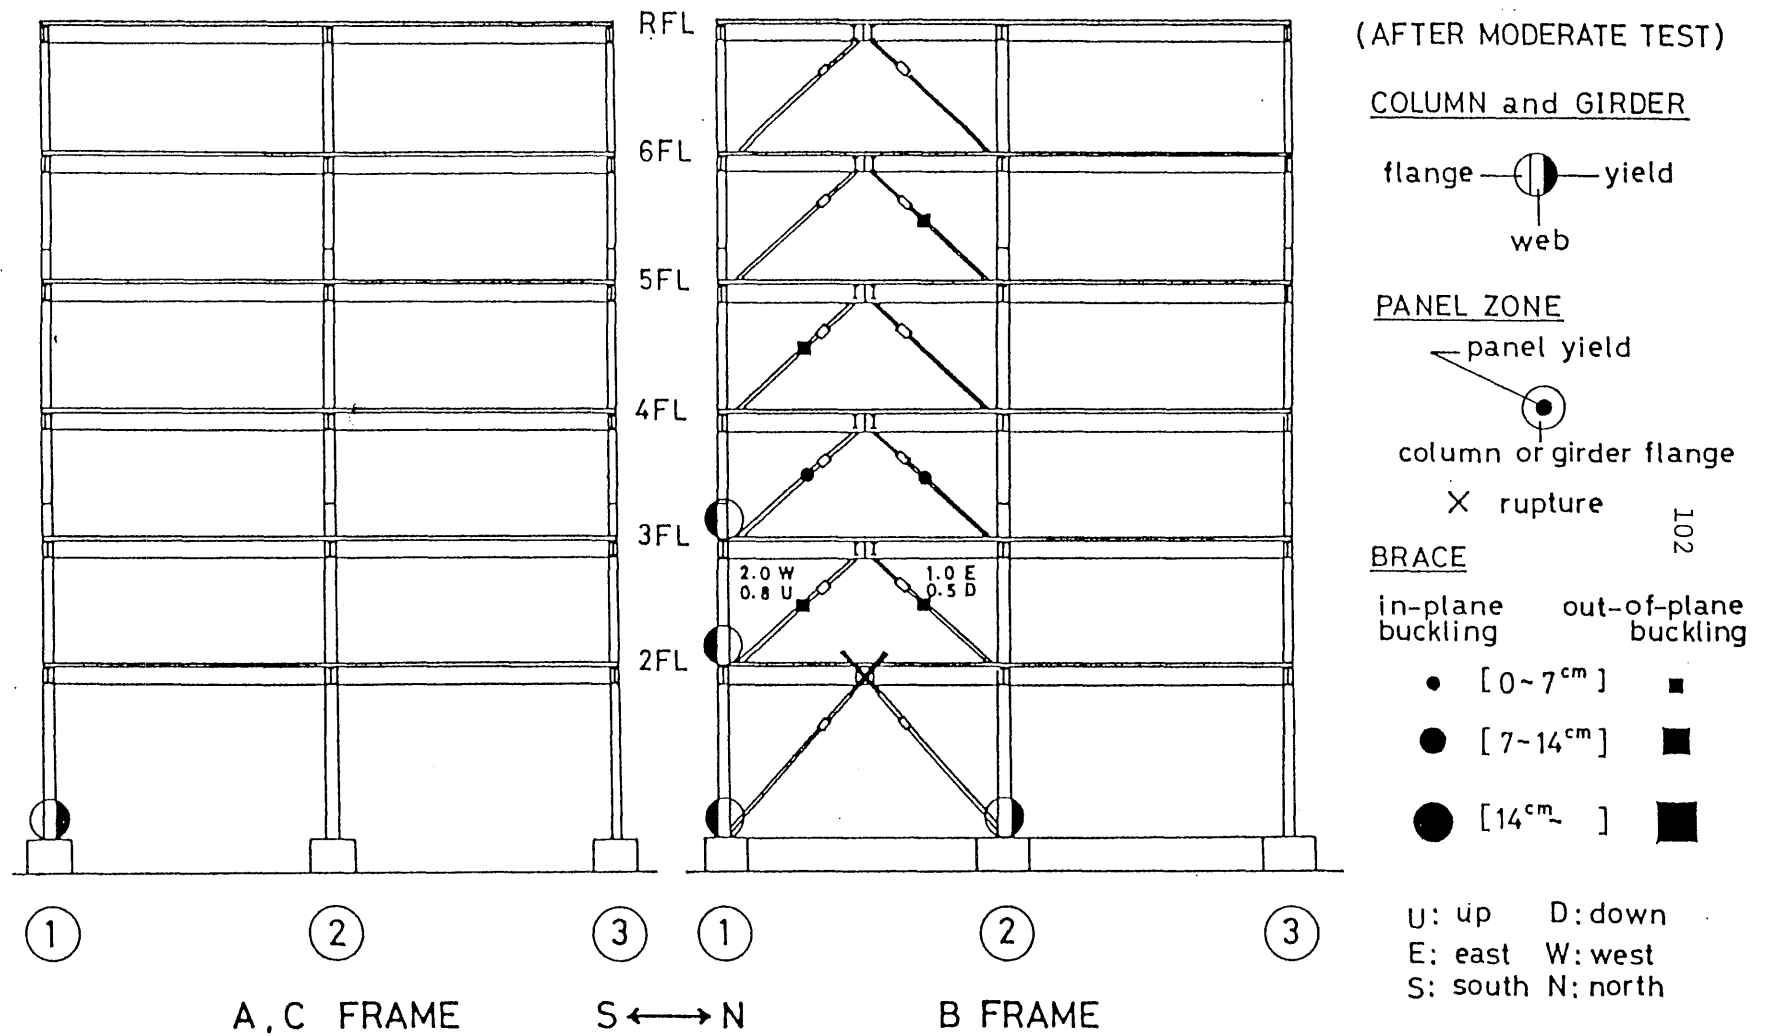
At the end of the Moderate test, a small amount of structural damage was observable. Figure 4.12 is a graphical summary of this observed damage after completion of the Moderate tests. Limited brace buckling and plastic deformation was noted on the 2nd and 3rd floor levels and some concrete cracking was observed, but the structure appeared to be in good condition. Observation of the force-deflection hysteretic curves indicated that the structure remained essentially linear elastic in the 4th, 5th, and 6th stories, although buckling was initiated in the north brace of the fifth story. Limited energy dissipation was noted during the later cycles of response for the 2nd and 3rd levels, because of yielding and buckling of the braces. However, the first level dissipated a large amount of energy (see Fig. 4.9) without apparent brace buckling or yielding. The hysteresis loops showed significant deterioration in the stiffness and load capacity of this level during the last few cycles of vibration response. Further, Table 4.1 shows that there was significant reduction in stiffness and increase in natural period after this test.

Fig. 4.12 Summary of damage observed after the Phase I Moderate test

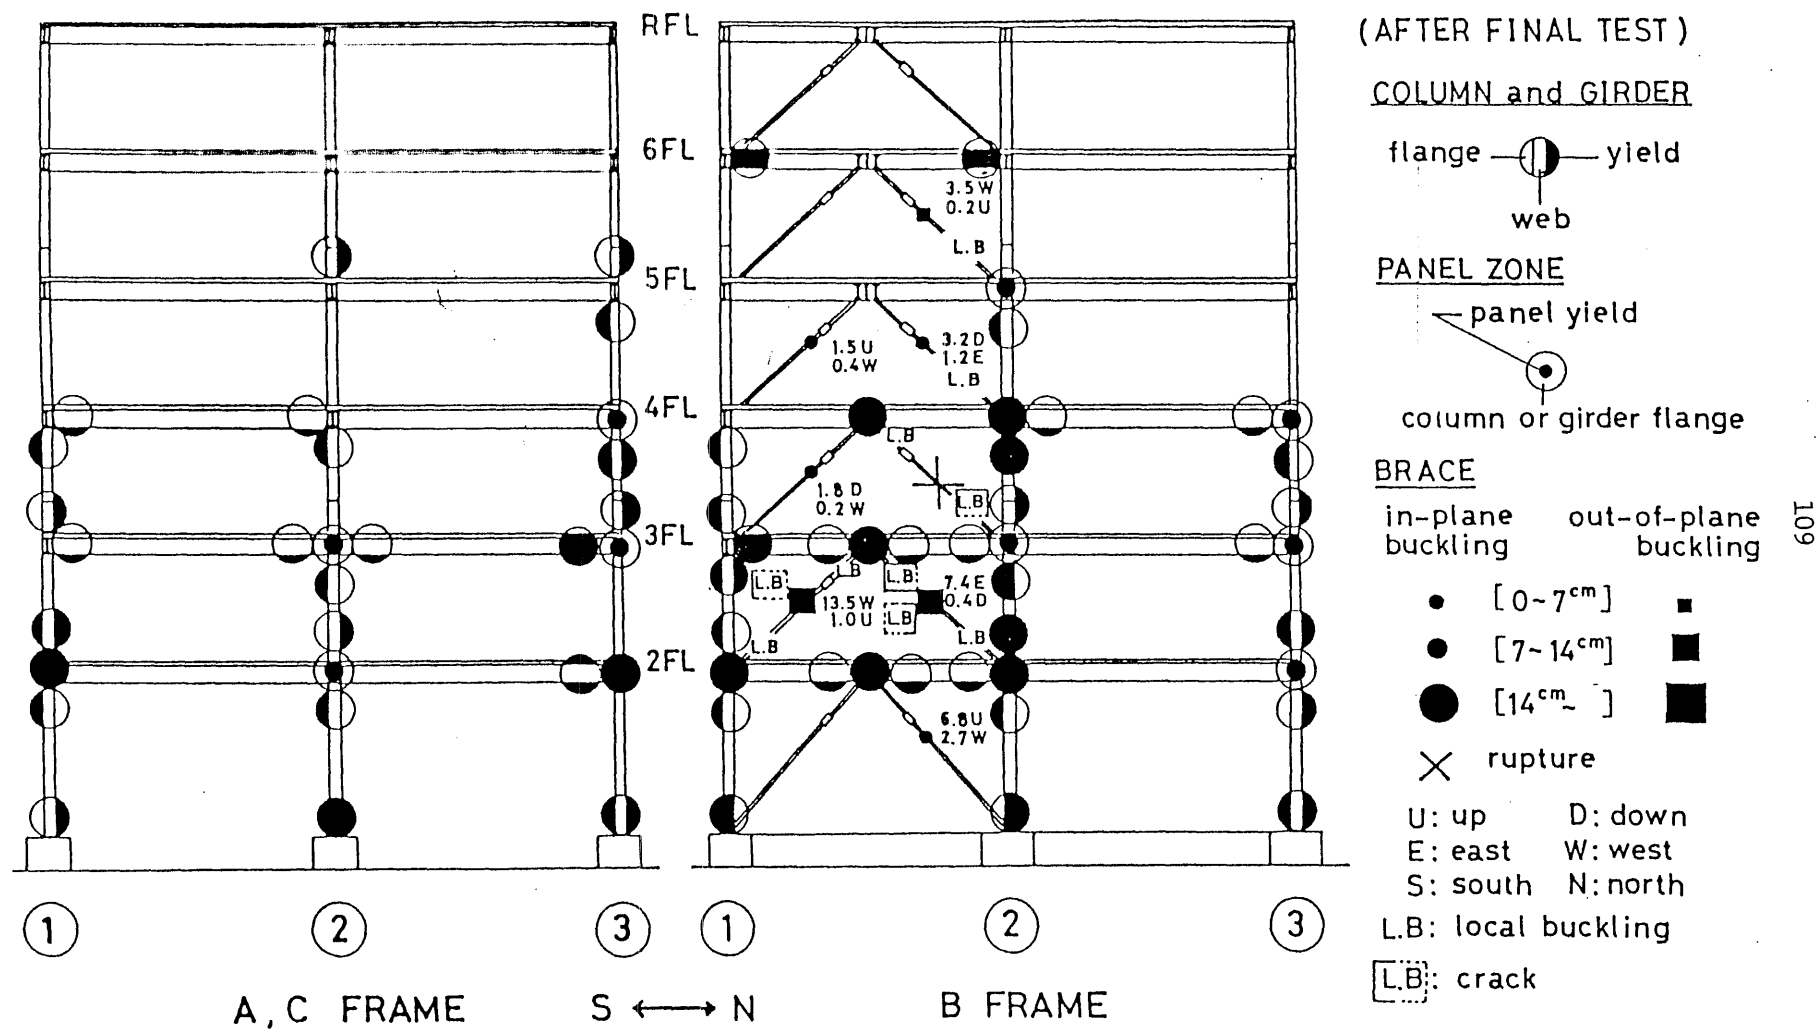
Additional structural damage was noted during this Final Test of Phase I. In-plane brace buckling occurred on the north brace of the 4th level and to a lesser extent the north brace of the 1st level. Very limited out of plane buckling was noted on the north brace of the 5th level. Slab cracking was most severe on the 2nd and 3rd floors and decreased for the upper floors. Slab cracking generally initiated at or near the K-brace connection and center column line. Cracking was much smaller and less widely distributed on the north and west sides of the structure. The crack patterns for the Z2 and Z3 floor slabs are shown in Figs. 4.23 and 4.24. The 2nd level composite floor slab also exhibited signs of separation from the steel beam because of the large cyclic reversals induced by the bracing. Measurements indicated that the concrete slab and metal deck were separated by several centimeters (i.e., in order of 1 inch) on the Z2 level at the end of this test. The beam splice connections for the 2nd and 3rd level (i.e., Z3 and Z4 girders) experienced the same twisting prying action noted for the Z2 girder in the moderate test but fracture did not occur (see Fig. 4.25).

Fig. 4.18 Schematic of damage observed after the Phase I Final test (from Ref. 7)

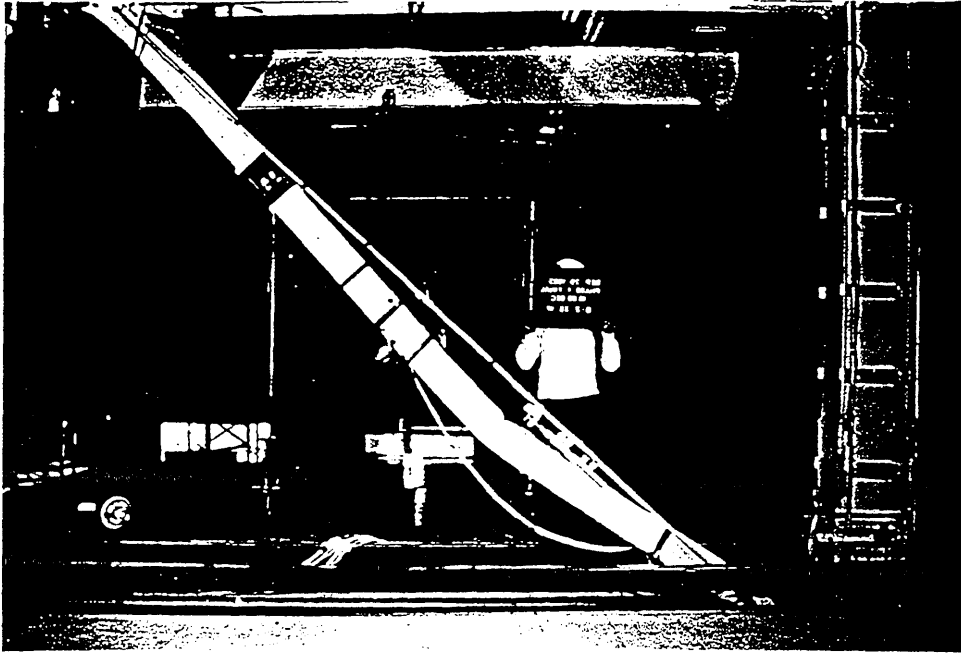
Fig. 4.21 In-plane buckling of brace during the
Phase I Final test

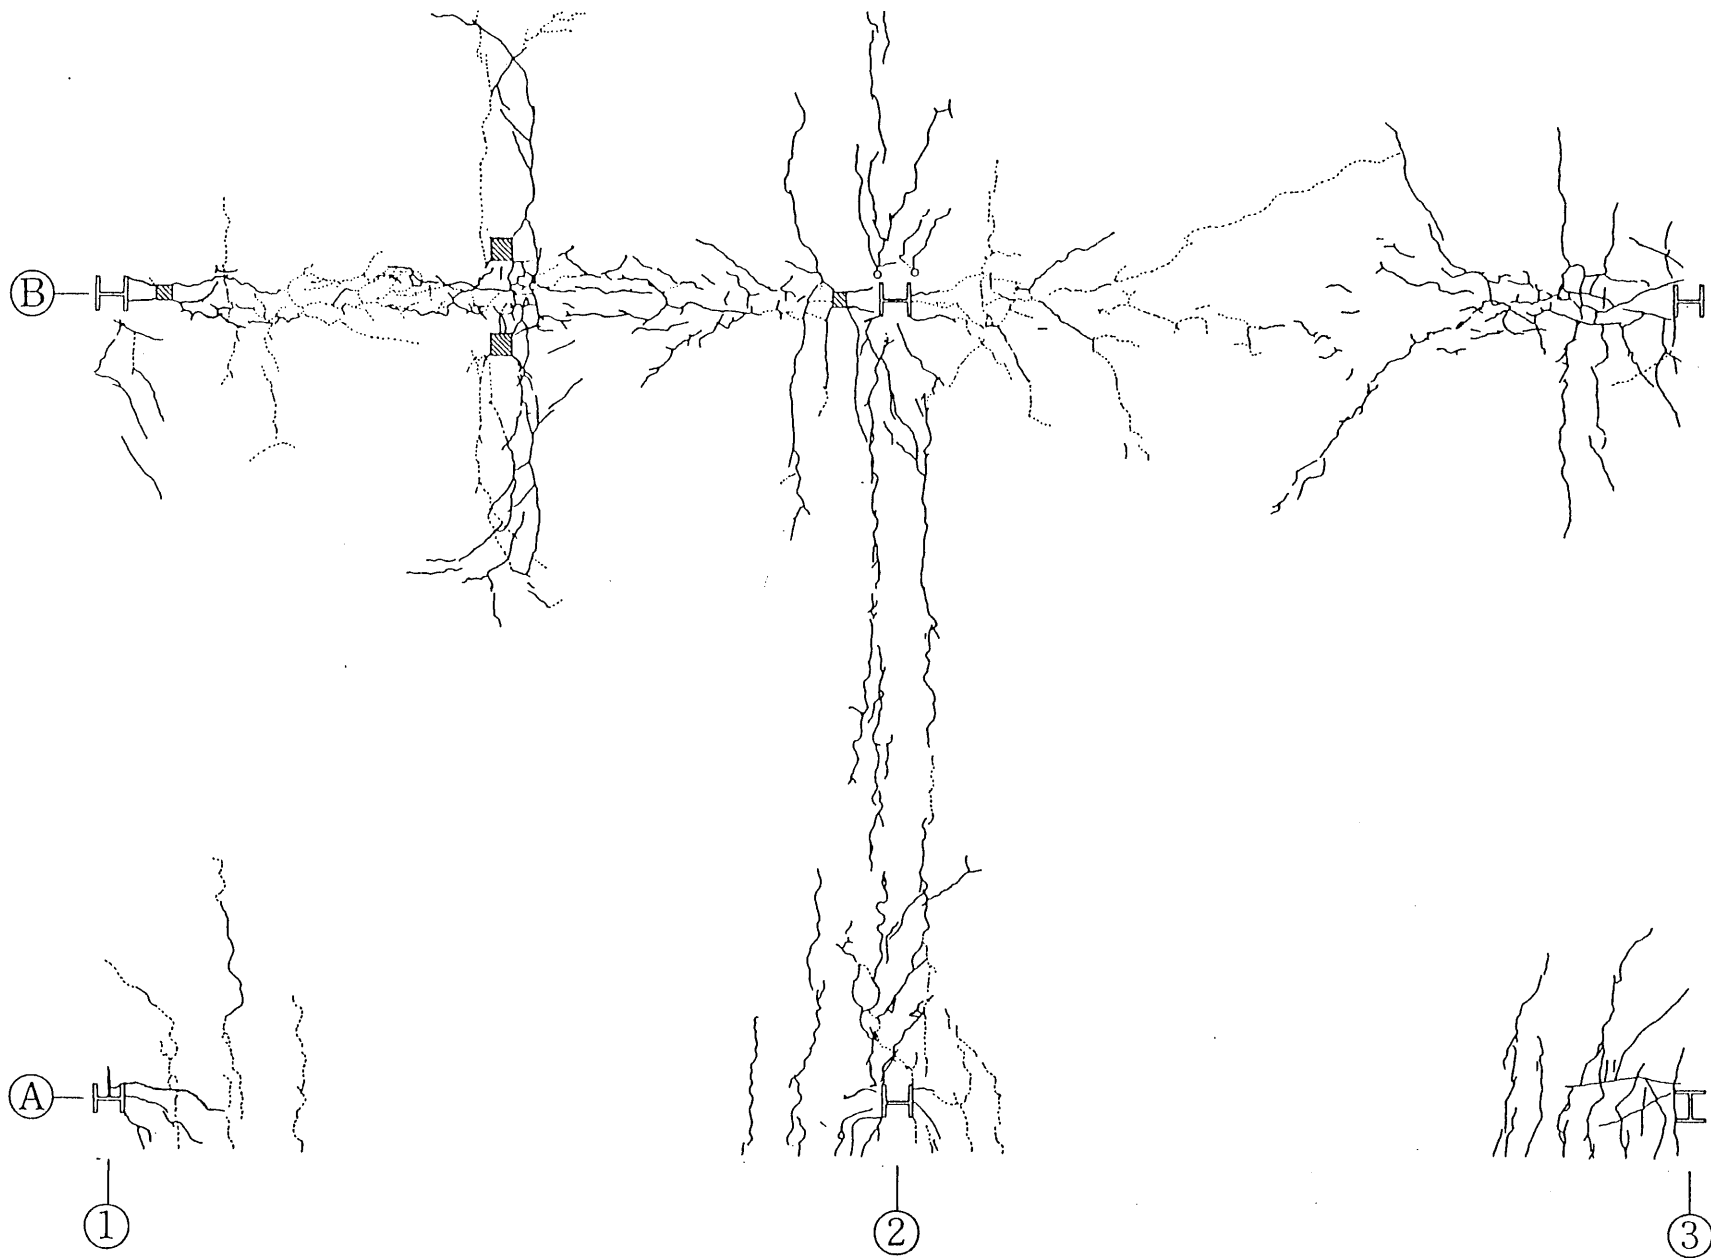
Fig. 4.23 Pattern of cracks following the Phase I Final test for the floor at the Z2 level

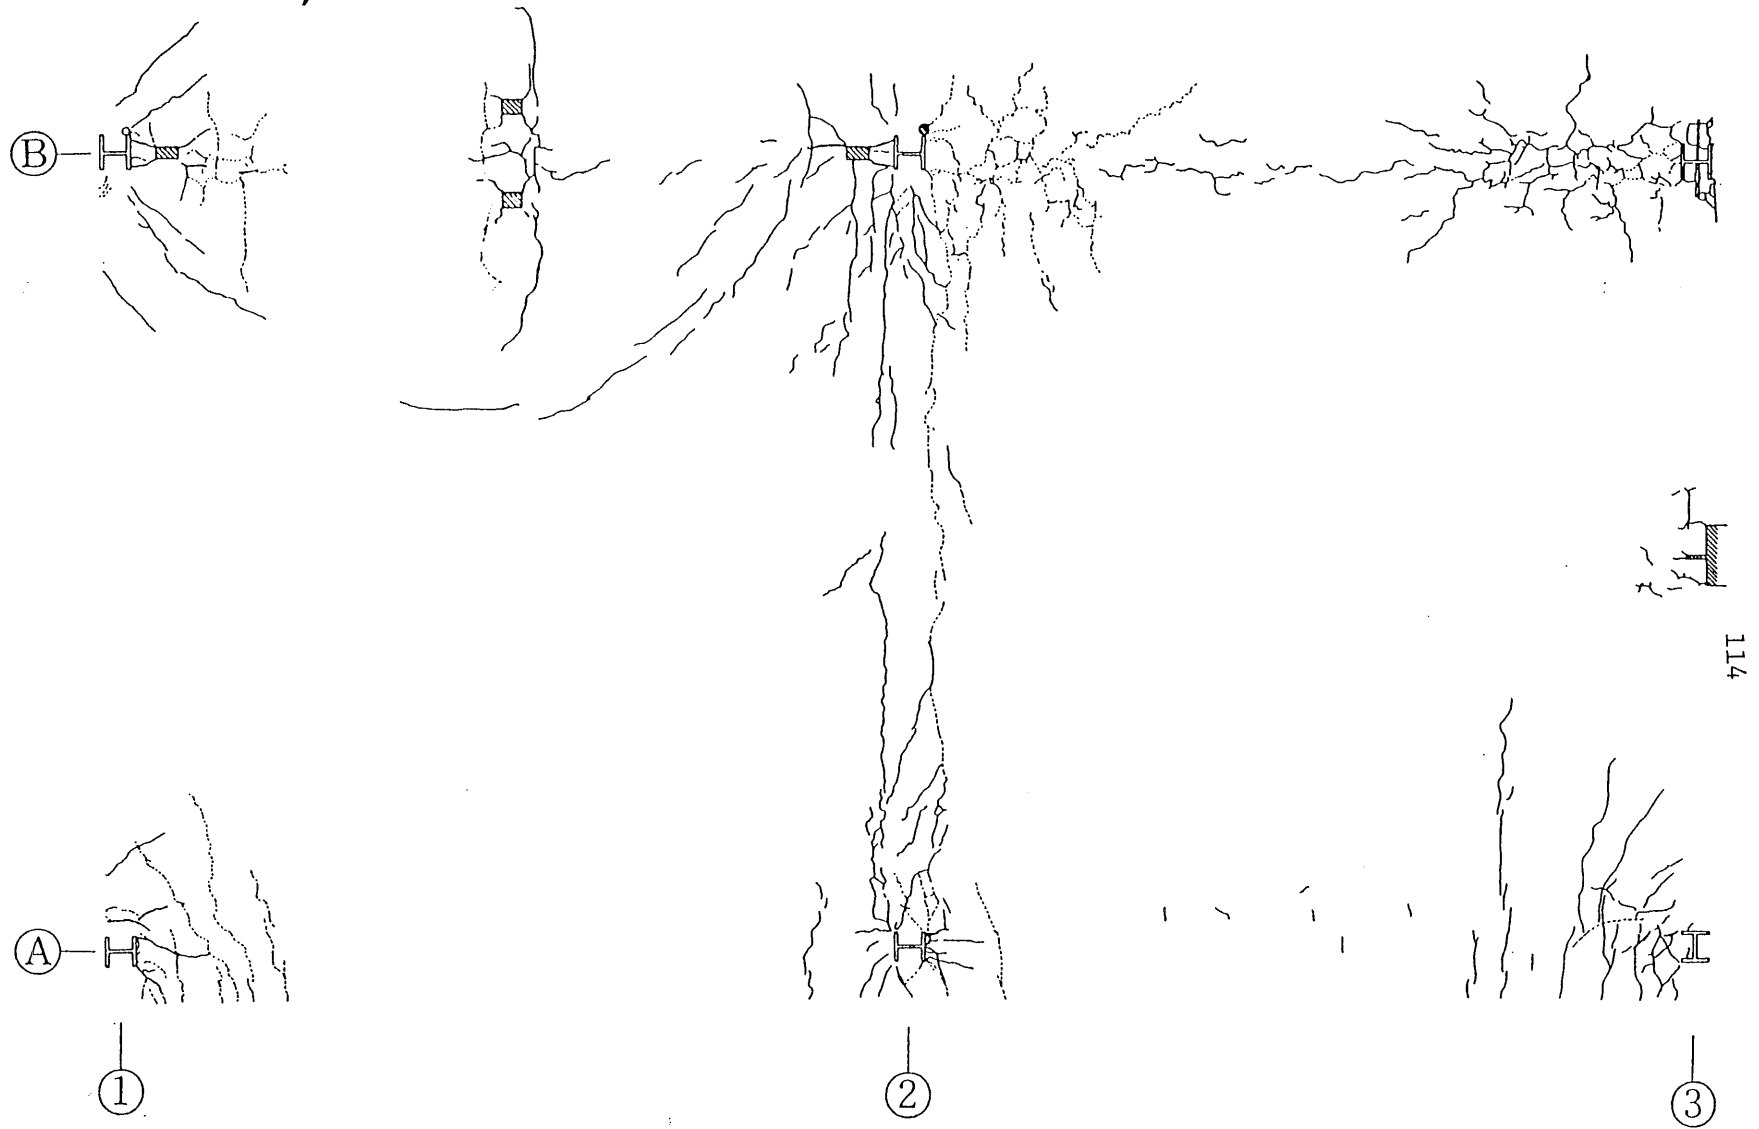
Fig. 4.24 Pattern of cracks following the Phase I Final test
for the floor at the Z3 level

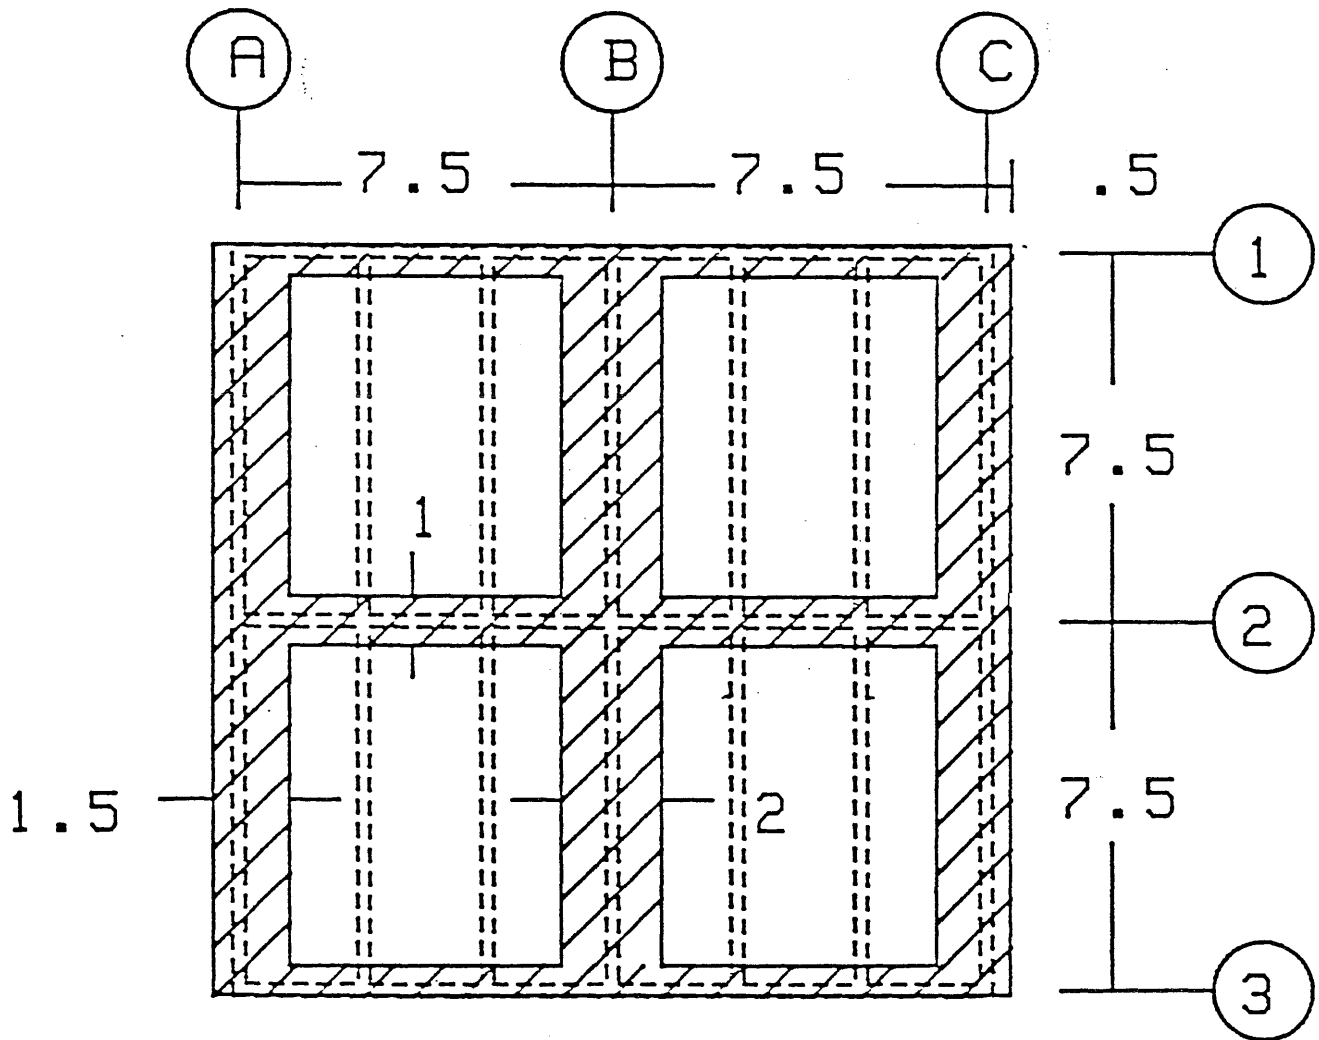
Fig. 5.2 Locations on each floor where epoxy injection was used to repair cracks resulting from the Phase I tests

area where epoxy injection was used is shown in Fig. 5.2 and some typical cracks are shown in Fig. 5.3. The concrete was recast at several locations where it had cracked excessively or where the slab was cut for other structural modifications such as the brace to beam connections for the Phase II structure.

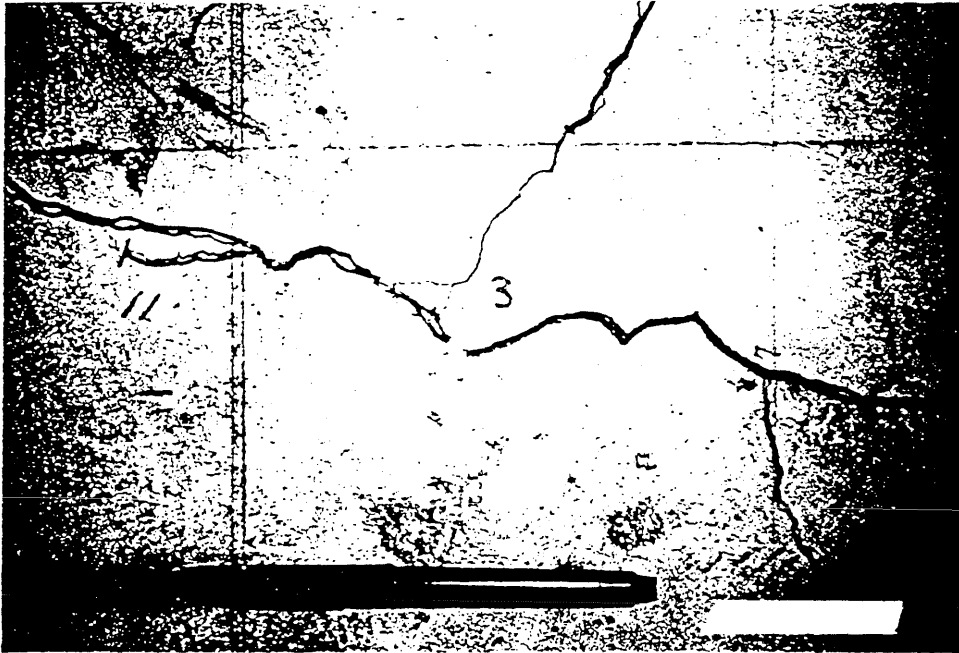
Fig. 5.3 Typical cracks prior to repair
